苏州蒙特纳利驱动设备有限公司
地址：苏州市吴江区汾湖高薪开发区长葑荡路 66 号

明函

关于市场监管总局 2021-4-14 发布的《市场监管总局办公厅关于开展电梯鼓式制动器安全隐患专项排查治理的通知（市监特设函〔2021〕564号）》中所述的“2. 重换鼓式制动器松闸复位后，定位装置未自动复位，导致制动力矩不足，造成曳引机抱闸失灵”问题。

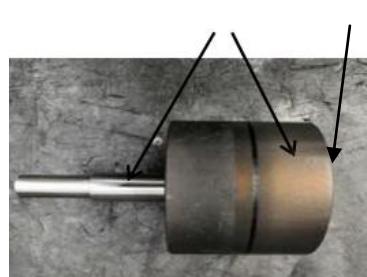
0.05mm

制动器内部维护完毕后，请按拆序逆序装配。

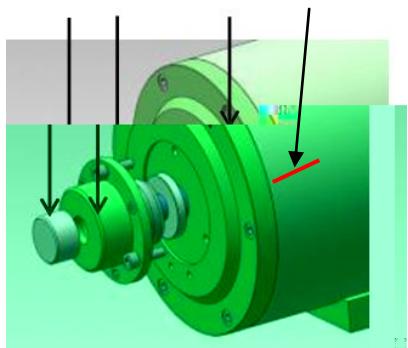
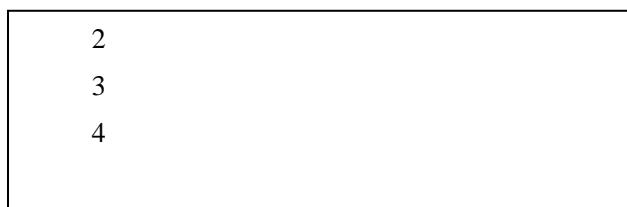
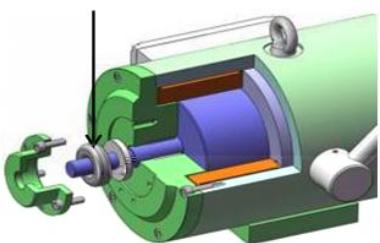
0.05mm

制动器内部维护完毕后，请按拆序逆序装配。
